Maryland Historical Trust Maryland Inventory of Historic Properties Form

Inventory No. HO-467

historic	Cooney-Smith Farm
other	George Richardson Farm, MacBeth Farm

street and number	12799 Clarksville Pike	___	not for publication
city, town	Clarksville	<u>X</u>	vicinity
county	Howard

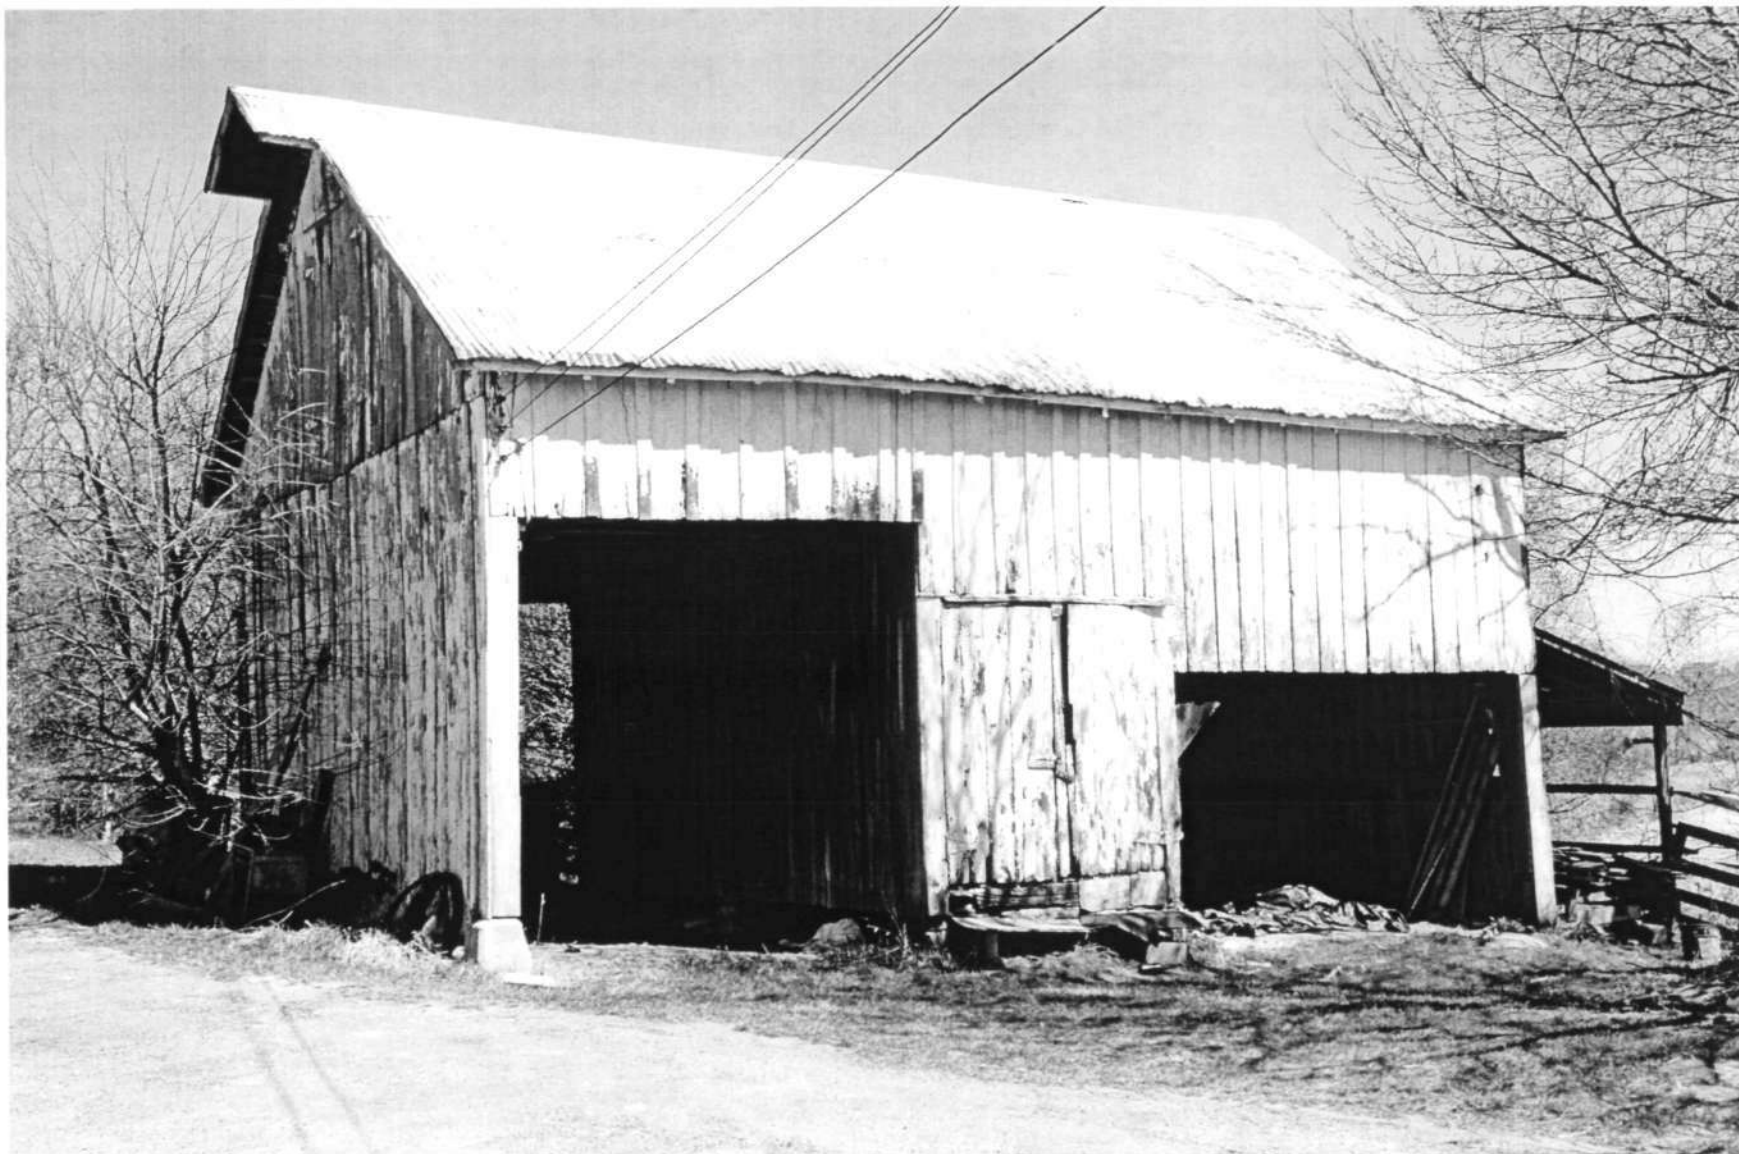
HO-0467 Cooney-Smith Farm 12799 Clarksville Pike, Wagon shed & corn crib-west & south elevations
Ken Short, March 2006 12/20

The wagon shed and corncrib are about 150 feet south-southeast of the house and are set on rubble stone piers. It is a frame structure with board and baton siding and a gable roof with corrugated metal, an east-west ridge and exposed rafters. It is a 1-1/2 story three-bay by one-bay structure. On the south elevation, the west bay has a wide, tall opening and there is no evidence that there were ever doors here. The center bay has a pair of vertical doors on T hinges, and the east bay has a wide but shorter opening than the west bay, and also has no evidence of doors. On the west elevation, there is a pair of board-and-batten doors on the gable end, and the roof overhands here and contains a chain to hang a pulley. The north elevation has a large opening in the west bay only. The east elevation has no openings, and there is an open shed added to this side. The building is constructed with a circular-sawn heavy timber frame that is mortised and tenoned and wire nailed at the foot. It is possible that the sill has been replaced, since the girts are pegged. The west door on the south elevation leads to the corncrib, while the east door leads to a winder stair that ascends to the east to the upper story. The building is of wire nail construction. The upper story is wide open and has 2 by 5 circular-sawn rafters that are mitered at the ridge, and several pairs of 3/4-round rafters that are also mitered. The plates sit on top of the posts, while the girts are dropped, and there are iron tie rods bolted to the top of a middle post on the north and south and pass through the floors at an angle. The top of the plates is 3 feet 3 inches above the floor. The rafters support the wood lath.

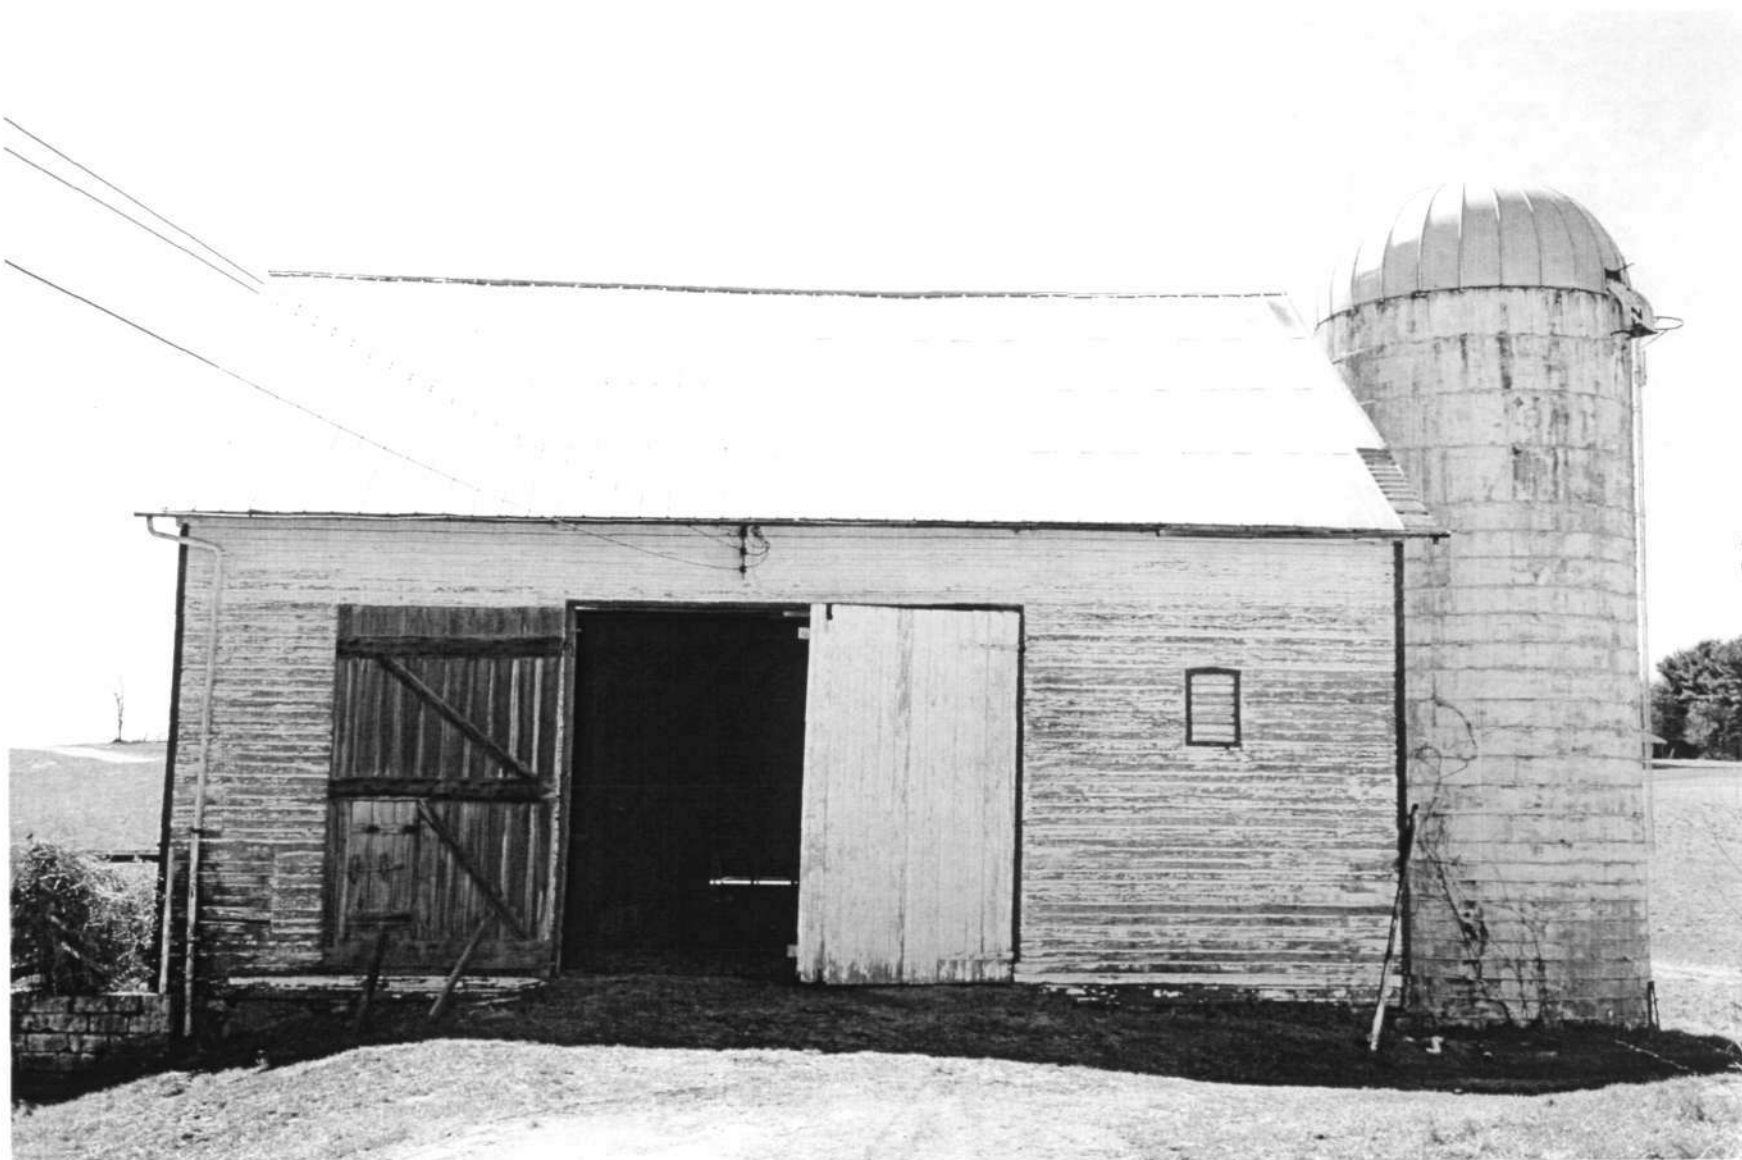
HO-0467 Cooney-Smith Farm 12799 Clarksville Pike, Barn-north elevation
Ken Short, March 2006 13/20

The barn is banked on the north with a cantilevered forebay on the south, and has a rubble stone lower story, a frame upper story

with German siding fastened with cut nails, and a gable roof of inverted V-seam metal with a east-west ridge. The barn is three bays by two bays. On the north elevation, the upper story has pair of large vertical board wagon doors in the center, hung on machine made straps. The hinge hooks are attached to plates bolted to the posts, and the plates are covered by a trim board. There are exposed rafter ends, and the first extend beyond the wall on the exterior, suggesting that a knob and neck joint was used here.

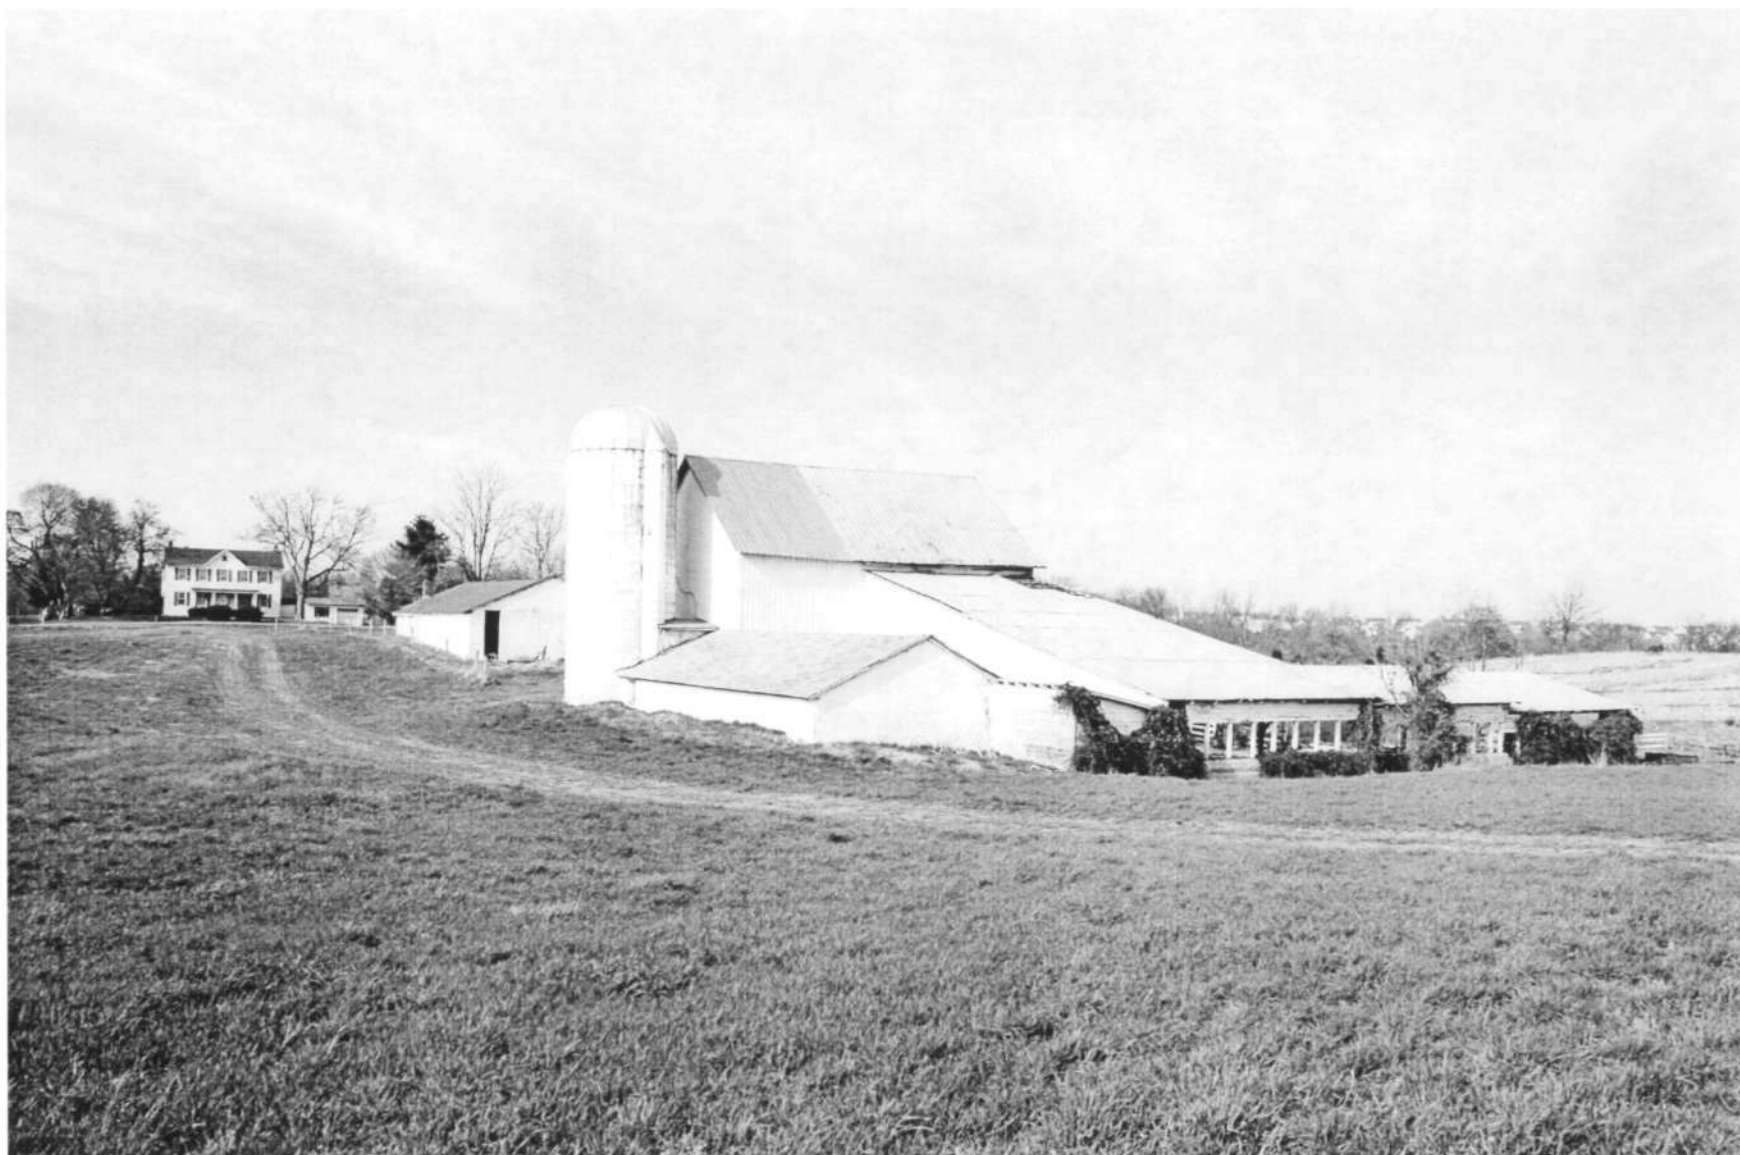
HO-0467 Cooney-Smith Farm 12799 Clarksville Pike, Barn-west & south elevations
Ken Short, March 2006 14/20

The lower story of the west elevation has a window opening in the north bay. There is a concrete silo with iron hoops connected to the south bay. The upper story is covered with inverted V-seam aluminum. The lower story of the east elevation has a window opening on the south bay, and there was also a shed attached here constructed of CMUs, 2 by 4s, and plywood, though it has now been mostly demolished. The north bay is covered by debris. The upper story is covered with aluminum like that of the west elevation. The south elevation is covered by a modern loafing shed. The lower story has German siding and a wide opening in the center with vertical board doors hung on T hinges. The end bays each have the bottom half of a vertical board Dutch door on T hinges. The board siding on the south elevation is painted white with dark green trim. The upper story of the south elevation has a large door made of German siding and hung on rollers in the center, a small wood louvered vent in the east bay, and the west bay is covered with siding.

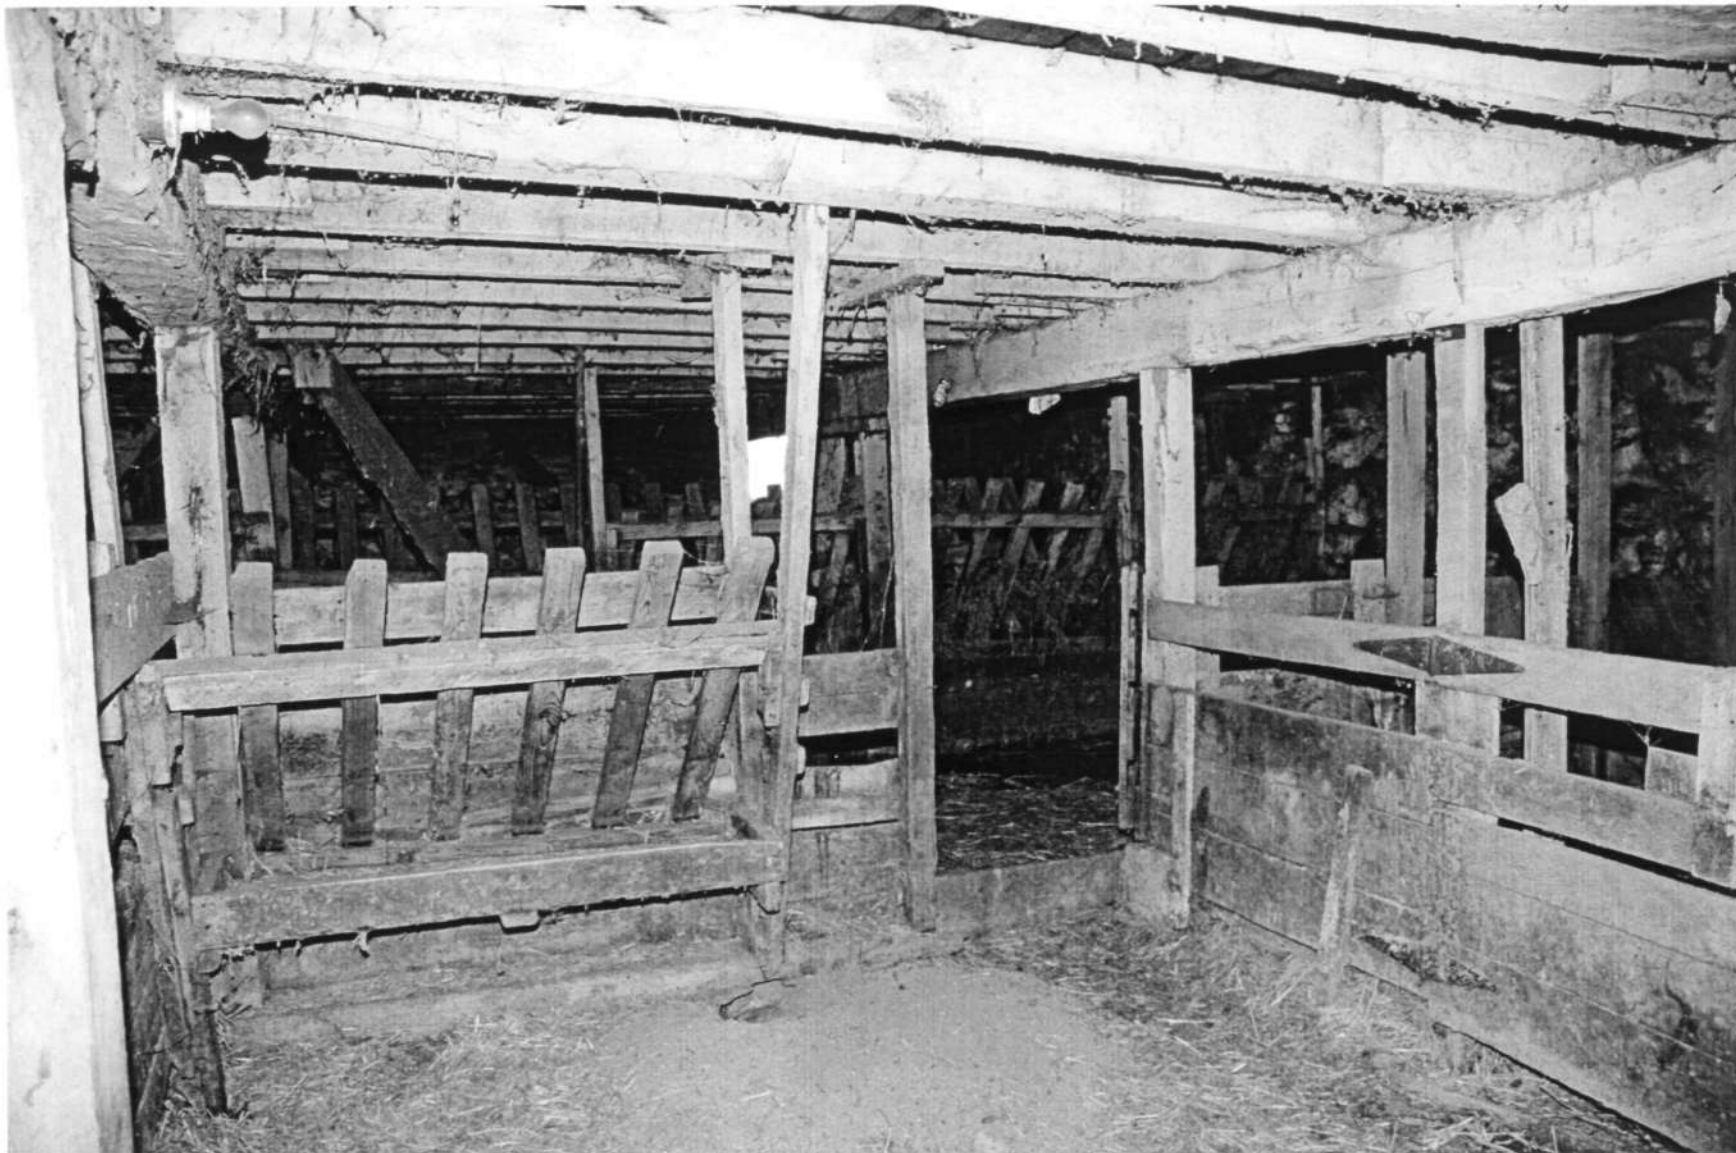
HO-0467 Cooney-Smith Farm 12799 Clarksville Pike, Barn-lower story interior, view west
Ken Short, March 2006 15/20

The lower story interior has a wide center aisle with one large pen on the west that has a hayrack between the west and center bays. There is an aisle on the east wall with a pen at the north end and two small pens between the center and east aisles. The interior arrangement appears to be original. There are two summer beams that are hewn, are about 9 inches wide by 10 inches deep, and run east-west. The joists are circular sawn and run north-south. They are 3 inches by 7-1/2 inches and are spaced 23-24 inches on centers. They run from the north wall to the north summer beam, from the north summer beam to the south summer beam, and from the south summer beam over the south lower wall to the end of the cantilever. The joists have a center tenon into the four-bay sill, and there is no evidence of pegs. The east elevation has a closed up window opening in the north bay, and the west elevation has no opening in the south bay. There is a stair from the center aisle up through a trapdoor on the west side of the aisle. The stair ascends to the south.

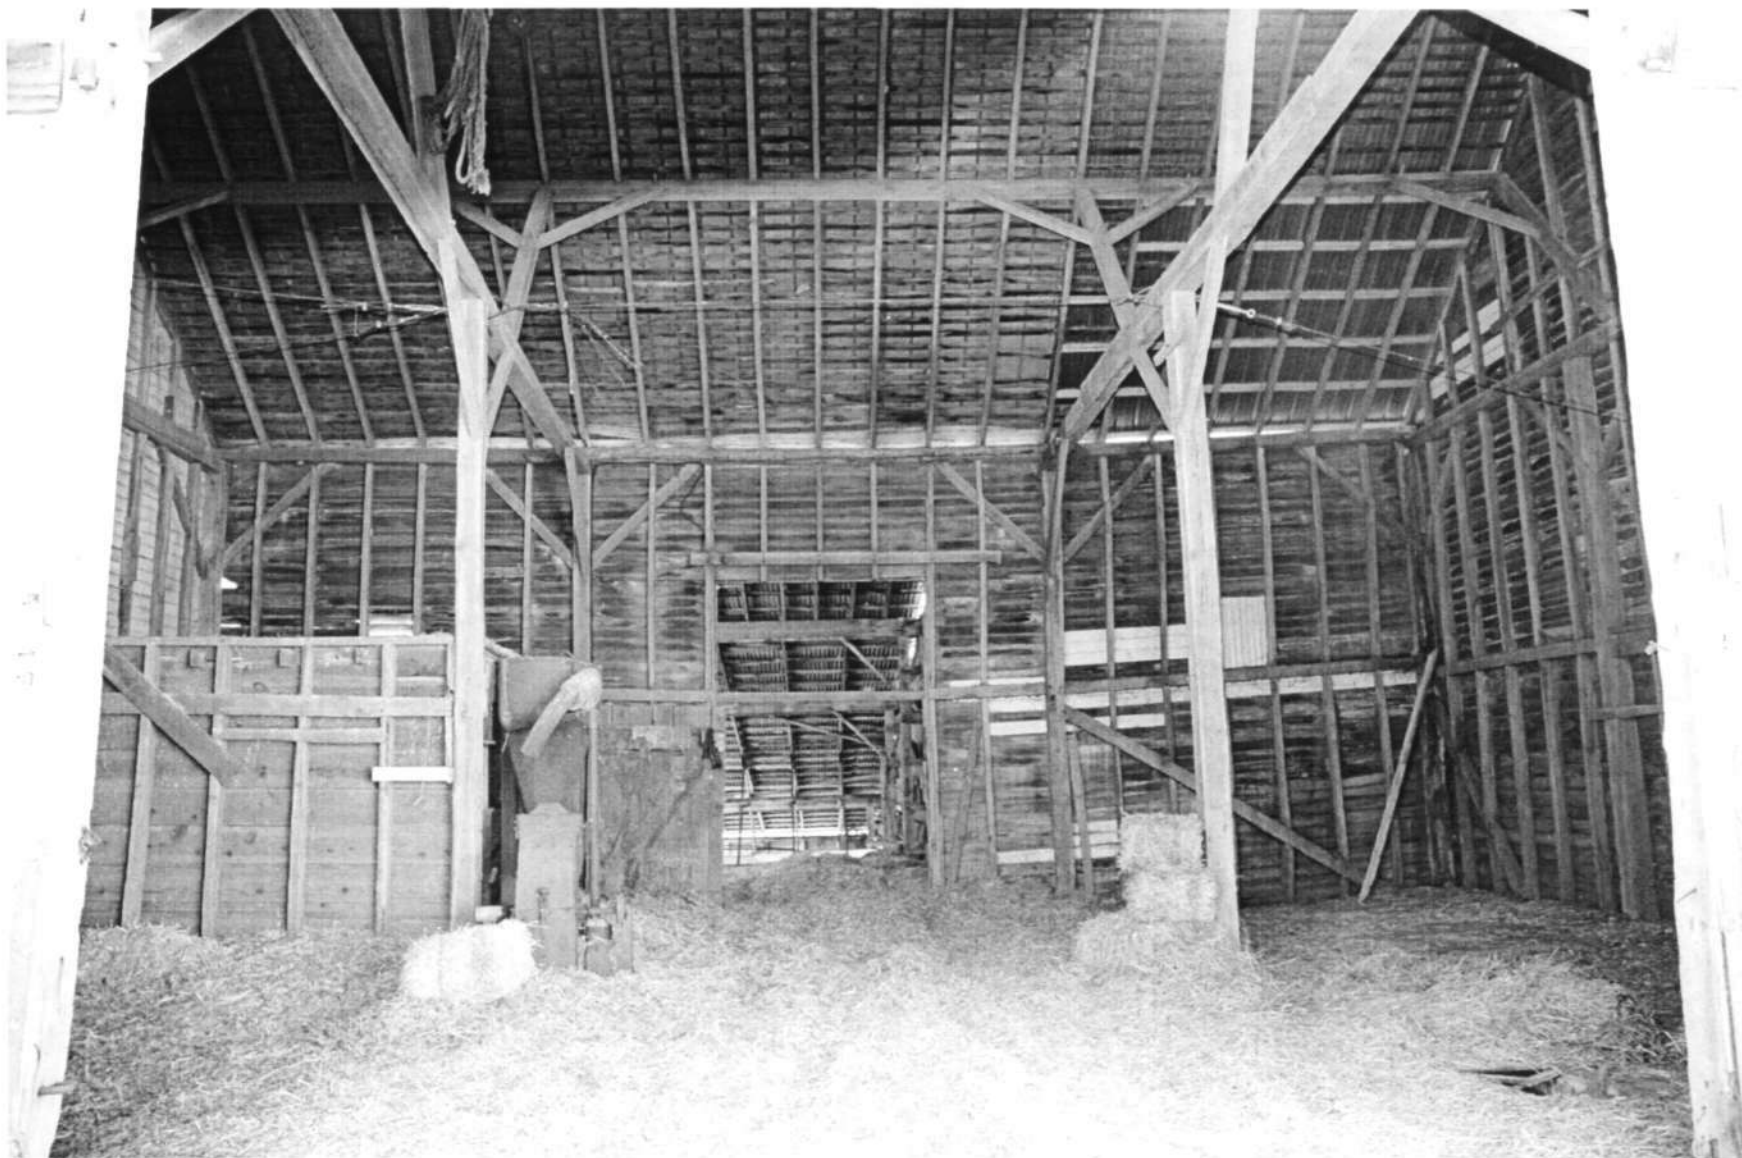
HO-0467 Cooney-Smith Farm 12799 Clarksville Pike, Barn, upper story, view south
Ken Short, March 2006 16/20

The upper story has a center-threshing floor with a hay mow to each side. The southern half of the eastern mow is enclosed with three rooms for storage, but there are no grain bins and no evidence that there ever were. There are vertical doors on butterfly hinges giving access to these rooms. The barn has a heavy timber, circular-sawn, mortised and tenoned and pegged frame. The center bents have one center post while the end bents each have two center posts, and there are both up and down braces and studs for horizontal siding. There are half-lap scarf joints with undersquinted ends, and four face pegs (one of which is offset because the stud is tenoned into here). The studs are tenoned at the top and bottom. The roof framing has purlin struts, and the rafters are mitered and butted at the ridge.

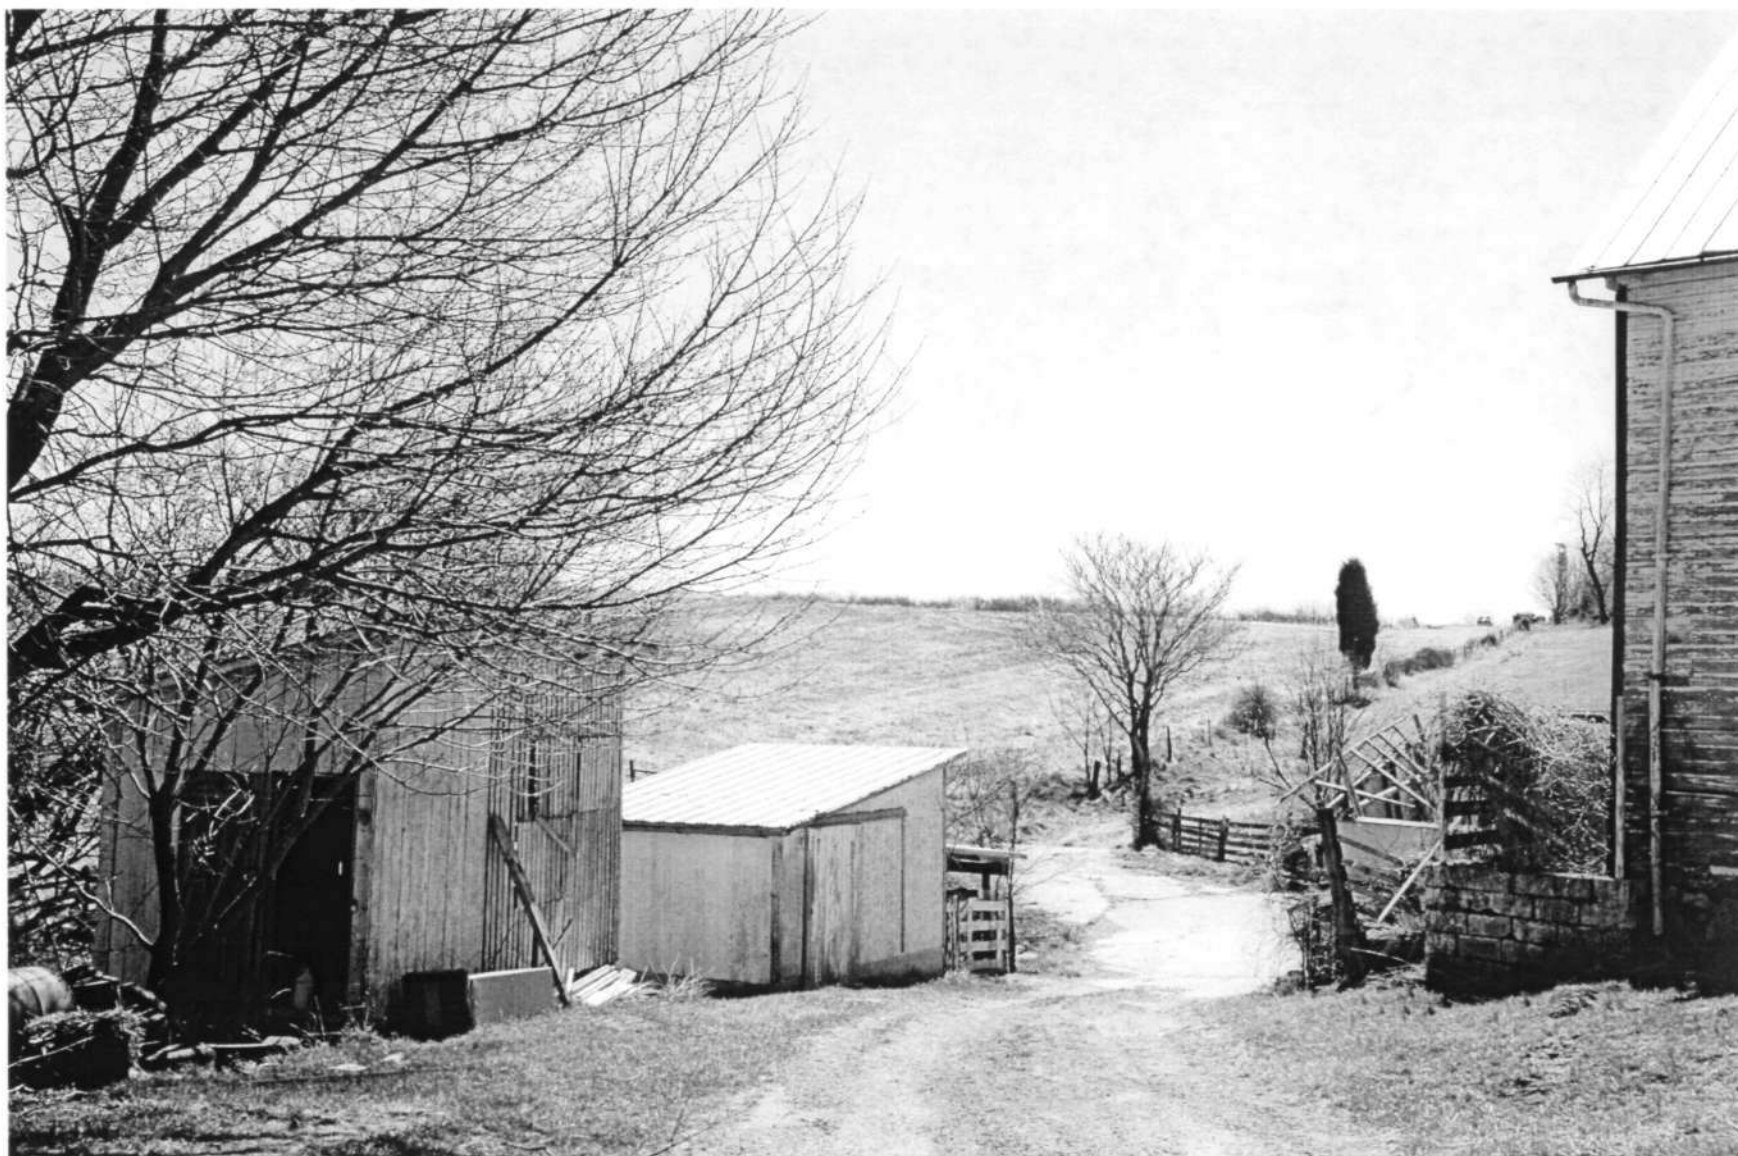
HO-0467 Cooney-Smith Farm 12799 Clarksville Pike, Corn crib & hog pen-north & west elevations
Ken Short, March 2006 18/20

piers with vertical siding on the north and the north half of the east and west elevations, and vertical slats on the rest of the building. There is a shed roof that slopes down to the east and has inverted V-seam metal. The west, south and west elevations have no openings. The north elevation has a vertical board door at the west corner hung on butterfly hinges. There is chicken wire on all of the interior walls, which are constructed of circular sawn 2 by 4s, which are predominantly doubled up. There is a vertical slat wall that divides the building into two, with doorway in it. The rafters are also 2 by 4s,

About 10 feet south of the corncrib is a hog pen with a CMU foundation, plywood, and a shed roof that slopes down to the north. There is also a shed roof that covers the yard on the south side of the building, which is not historic. About 100 feet east of the barn, in a separate field, is a shelter shed that faces southeast and is open on that side. It is set on the ground and has 2 by 4s with vertical boards and a shed roof that slopes down to the northwest and has inverted V-seam metal.

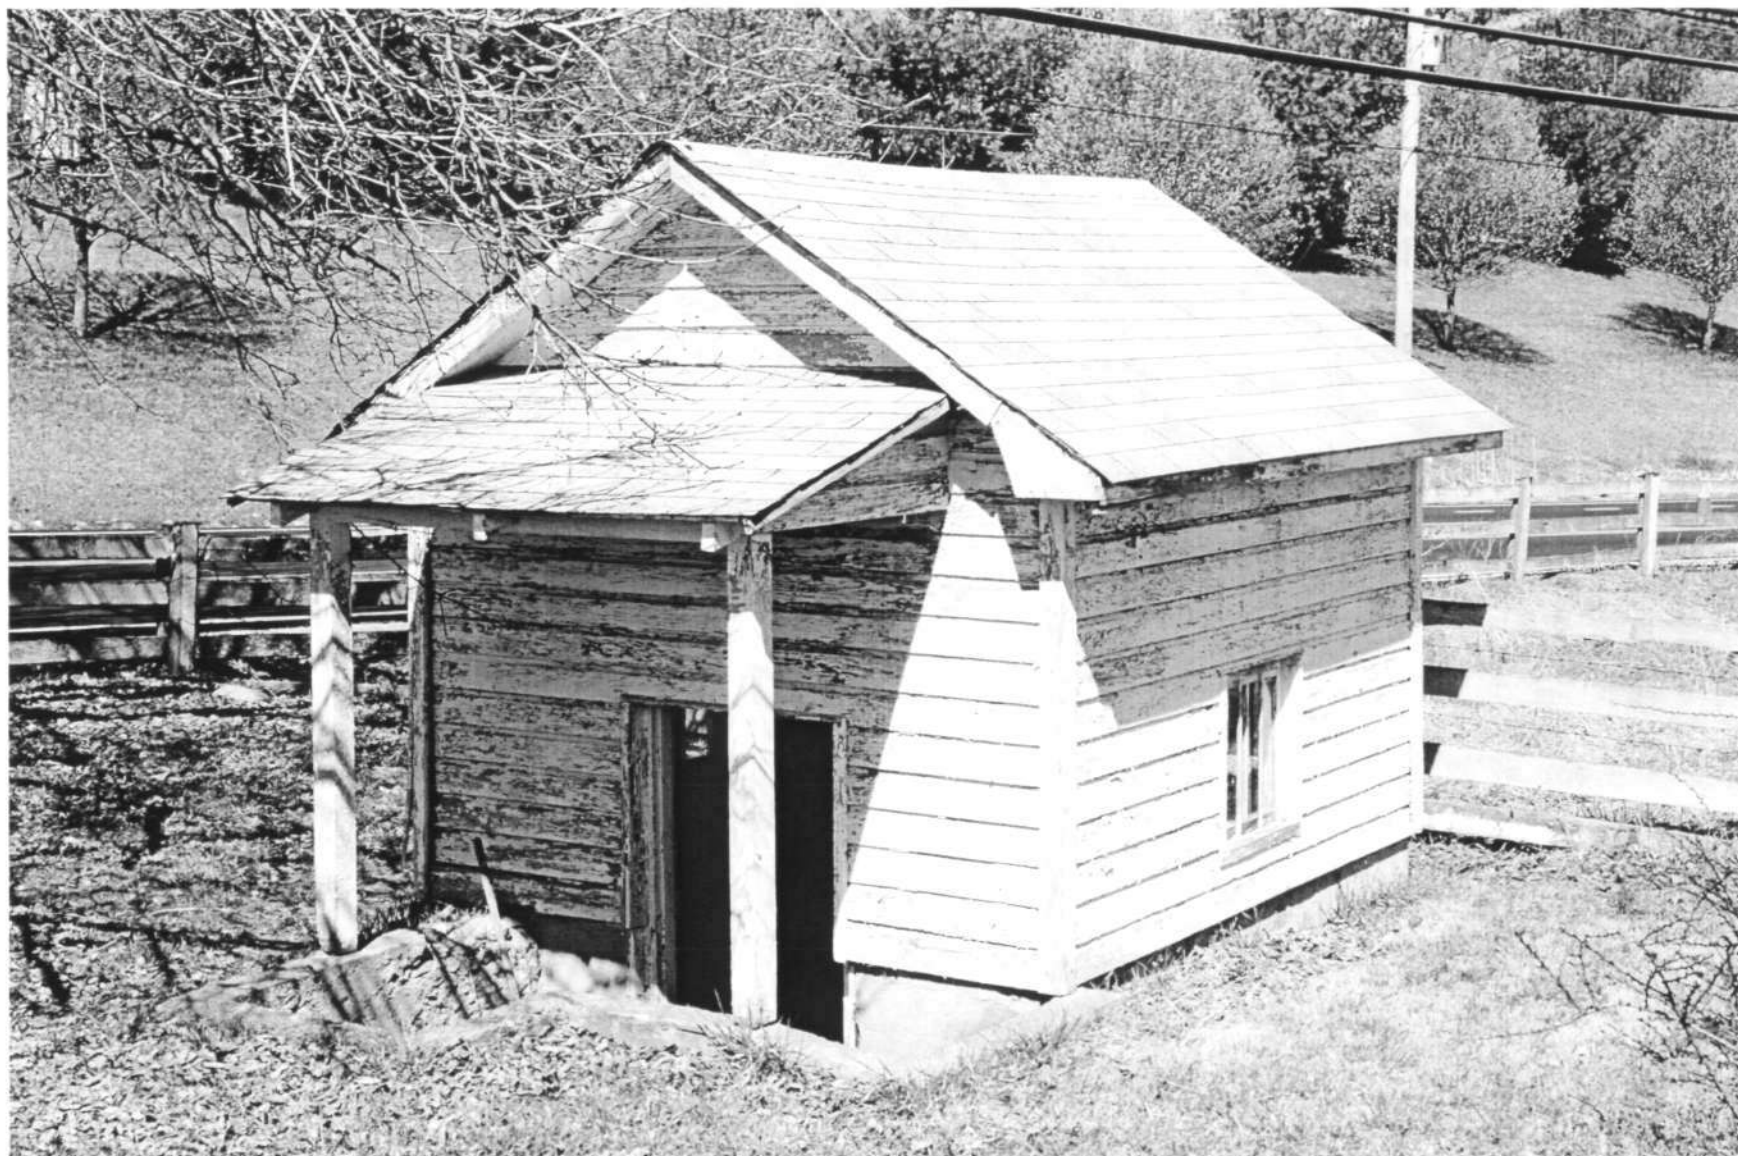
HO-0467 Cooney-Smith Farm 12799 Clarksville Pike, springhouse-south & east elevations
Ken Short, March 2006 19/20

The springhouse is located on the north side of the drive, next to Clarksville Pike. It is a one-story, one-bay frame structure with a concrete foundation, German siding and a gable roof with asphalt shingles and a north-south ridge. The south elevation has a rubble stone retaining wall that is parged with concrete, and there are concrete steps down from the east. A doorway is set at the bottom of the steps, and the door has tongue and groove vertical boards and T-hinges. There is a shed-roof porch over the door on two square wood posts set on the retaining wall. The siding has wire nails, and there is a box cornice. The east elevation has a two-light sash with two vertical iron bars. The north elevation has no openings, and the west elevation matches the east. The interior has a concrete floor with trough along the north and west walls. The building is constructed of circular-sawn 4 by 6 sills, 4 by 4 corner posts, 2 by 4 studs with downbraces, and 2 by 4 rafters that are mitered at the ridge. The northwest corner post has an extra piece added on top of the plate and girt to hold them together, apparently.
